Toyota Motor Sales, U.S.A., Inc. 19001 South Western Avenue Torrance, CA 90501 (310) 468-4000

SPECIAL SERVICE CAMPAIGN (SSC) - 60C (SAFETY RECALL)

(2004 THROUGH EARLY 2006 STEERING INTERMEDIATE SHAFT REPLACEMENT)

2004 THROUGH EARLY 2006 MODEL YEAR PRIUS STEERING INTERMEDIATE SHAFT REPLACEMENT

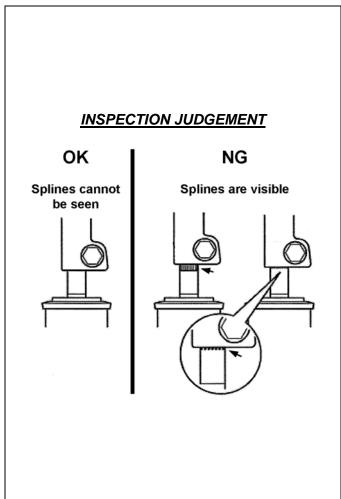
Be sure to look at the engagement point straight-on. If viewed from underneath the vehicle the ends of the splines can be seen, even when the intermediate (extension) shaft No. 1 is fully inserted onto the steering gear. This may lead to an incorrect judgment of the condition.

c) Are the splines of the steering gear visible?

- OK Condition (splines not visible): Proceed to step C.
 - "C. RETORQUE THE INTERMEDIATE (EXTENSION) SHAFT NO. 1 BOLT, INSPECT THE SLIDING YOKE AND REPLACE THE INTERMEDIATE SHAFT NO. 2" on page 09.
- NG Condition (spline visible): Proceed to step D.
 - "D. DETAILED INSPECTION OF THE INTERMEDIATE (EXTENSION) SHAFT NO. 1, INSPECT THE SLIDING YOKE AND REPLACE THE INTERMEDIATE SHAFT NO. 2" on page. 20.

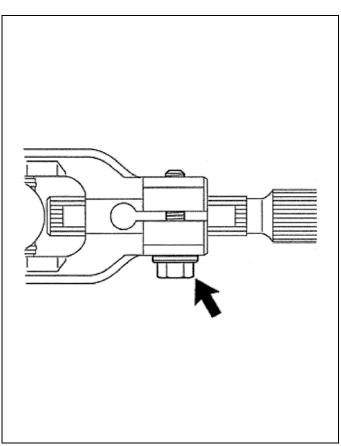
12. INSPECT THE SLIDING YOKE

Replacement is **NOT** necessary, reuse the sliding yoke.

Replace the sliding yoke with a **NEW** one.

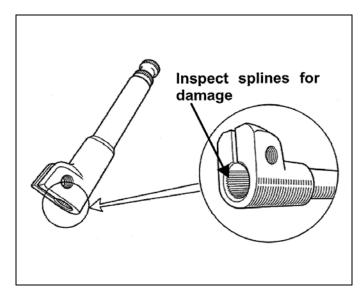
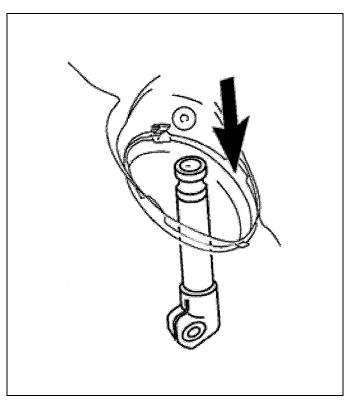
11. REMOVE THE INTERMEDIATE (EXTENSION) SHAFT NO. 1 AND INSPECT FOR DAMAGE

NG, damaged:

Intermediate (extension) shaft is NG.
Replace the intermediate (extension)
shaft No. 1 and the bolt with a NEW
one.
