**BULLETIN** *May 23, 2006*

Title:
FRONT SEAT SQUEAK NOISE

'04 - '07 Toyota & Scion

NV004-06

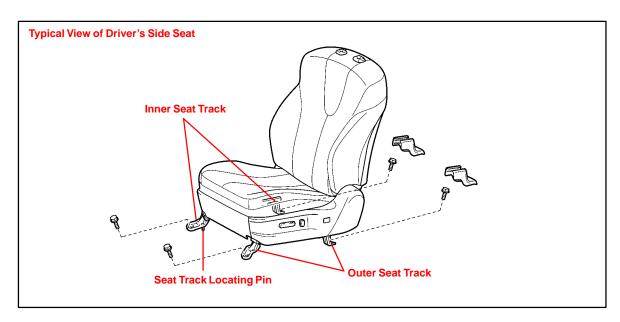
Parts Location

Some customers may experience a squeak noise due to contact between the seat track locating pin(s) and the floor pan location hole(s). The following procedure describes the repair method to correct this condition.

**Pin Location** The following table indicates the location and the number of seat track locating pins that should be removed from the seat track assembly:

- Remove the plastic rear seat track covers — Use the taped screwdriver to disengage the claws and carefully remove the plastic seat track covers.
- 4. Remove the LH front seat assembly.
  - A. Move the seatback to the full upright position.
  - B. Remove the four (4) seat track securing bolts.
  - C. Disconnect the electrical connectors and remove the complete seat assembly.
- 5. Remove the seat track locating pins.
  - A. With the seat removed from the vehicle, tilt the seat assembly backward to gain access to the seat track locating pins.
  - B. Use a power cut-off tool (or equivalent) to cut off the two (2) locating pins leaving 2 mm (0.1 in.) or less of each pin.

Do NOT permit the power cut-off tool to contact the seat track. ONLY cut off the shaft of the pin (near the base of the seat track).
