Introduction If a creak, tick, or rattle noise is heard at the top or bottom of the windshield, the source of the noise may be the two windshield stoppers bonded to the top of the windshield or the windshield retainers bonded to the lower edge of the windshield. This bulletin provides the recommended repair procedure to eliminate these types of noises from the windshield area.

- Applicable Vehicles**
- **2003 – 2007** model year **Toyota** vehicles.
 - **2004 – 2007** model year **Scion** vehicles.

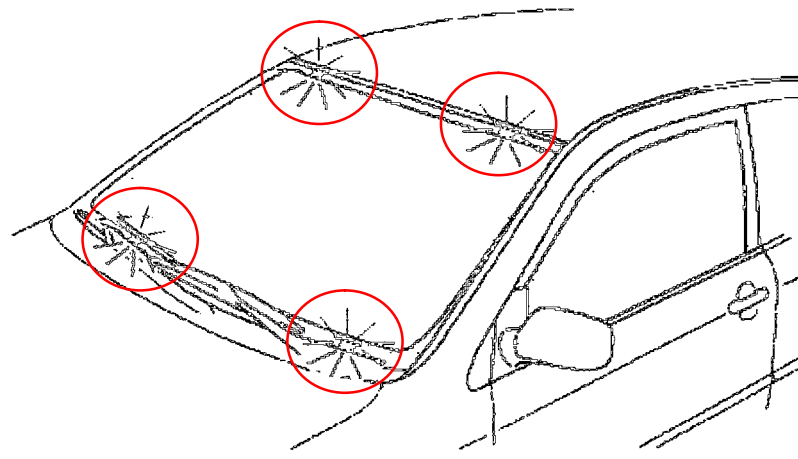
Pin Locations

The stoppers are located on the inside of the passenger compartment behind the windshield glass blackout section (near the top front edge of the metal roof opening). The stoppers are typically located 20 – 25 cm (7.9 – 9.8 in.) inboard of the top corners of the windshield glass.

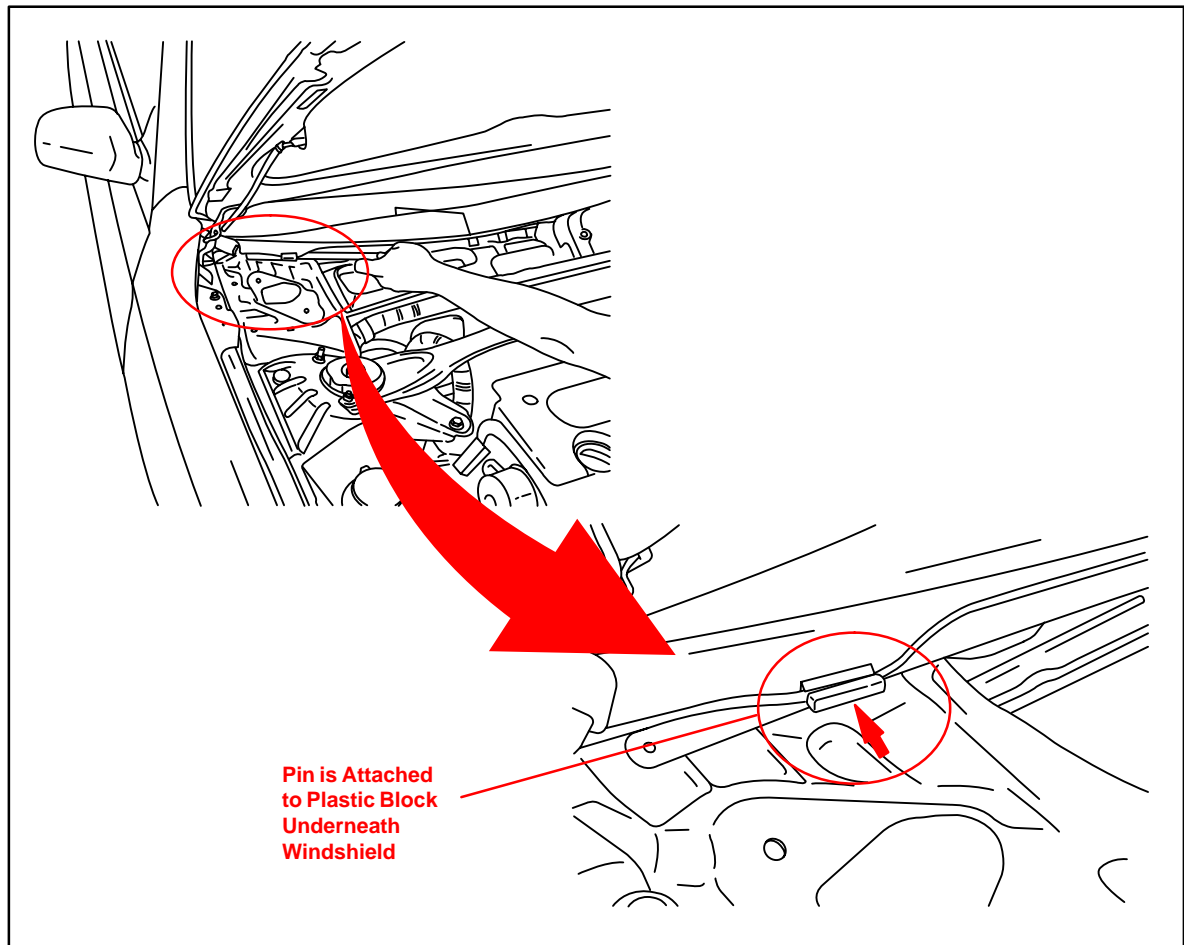
The retainers are typically located 140 – 200 mm (5.5 – 7.9 in.) inboard of the lower corners of the windshield. The flat portion of the retainer is adhered to the backside of the windshield with double-sided, foam-backed tape.
