Toyota Motor Sales, U.S.A., Inc. 19001 South Western Avenue Torrance, CA 90501 (310) 468-4000

SPECIAL SERVICE CAMPAIGN (SSC) - 60C (SAFETY RECALL)

(2004 THROUGH EARLY 2006 STEERING INTERMEDIATE SHAFT REPLACEMENT)

2004 THROUGH EARLY 2006 MODEL YEAR PRIUS STEERING INTERMEDIATE SHAFT REPLACEMENT

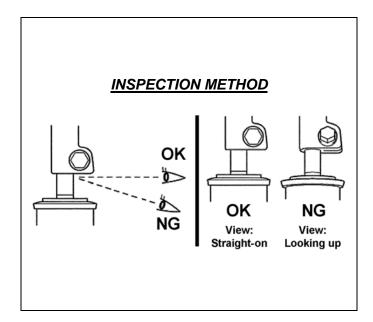
- a) Turn the steering wheel to the right.
- b) While holding up the column hole cover, inspect the engagement point for the intermediate (extension) shaft No. 1 and steering gear by looking at it straight-on through the opening on the backside of the left front wheel well.

Be sure to look at the engagement point straight-on. If viewed from underneath the vehicle the ends of the splines can be seen, even when the intermediate (extension) shaft No. 1 is fully inserted onto the steering gear. This may lead to an incorrect judgment of the condition.

- OK Condition (splines not visible): Proceed to step C.
 - "C. RETORQUE THE INTERMEDIATE (EXTENSION) SHAFT NO. 1 BOLT, INSPECT THE SLIDING YOKE AND REPLACE THE INTERMEDIATE SHAFT NO. 2" on page 09.
- NG Condition (spline visible): Proceed to step D.
 - "D. DETAILED INSPECTION OF THE INTERMEDIATE (EXTENSION) SHAFT NO. 1, INSPECT THE SLIDING YOKE AND REPLACE THE INTERMEDIATE SHAFT NO. 2" on page. 20.

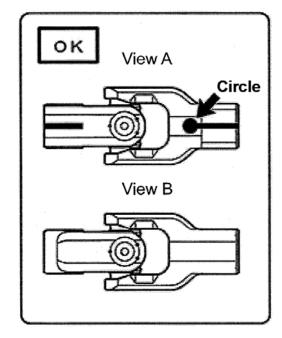
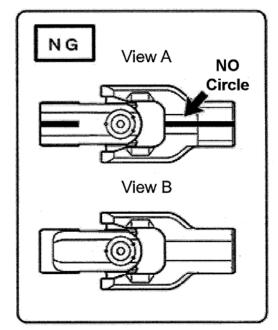
View A View B

a) Inspect the shape of the slot on the sliding yoke as shown in the illustration to determine if it is OK or NG.

Replacement is **NOT** necessary, reuse the sliding yoke.

Replace the sliding yoke with a **NEW** one.
